**Flood Control Project Maintenance
Levee Inspections**
LMA District Cover Sheet
Spring 2019 Levee Inspection Results

Reclamation District No. 0524 Middle Roberts Island

Spring 2019 Levee Inspection Results

Waterway			Bank	Unit Miles
Unit No. 01 San Joaquin River			Left	6.20
	Spring (March - May)	Summer (June - August)	(September - November) Fall	Winter (December - February)
Unit Maintenance Rating (Fall Only)				
Date of Inspection	3/26/2019 - 3/27/2019			
DWR Inspector	Alberto De Leon			
Accompanied By	Zach Jojola DWR

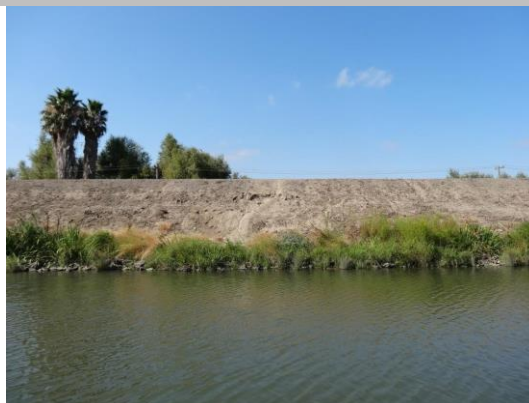
Photo 1 of 3 : SP_2019_RD0524_107_1_20190313_00001.jpg

LM Start	0.19	Rating **	U	Issue No.	1
LM End	0.19	Issue Type +	Ma	Location *	WS
Category	Supplemental			GPS Latitude/Longitude	
				Start	End
Item	DWR Erosion Survey			37.939085 °	37.939085 °
				-121.343917 °	-121.343917 °
DWR ID	RD0524U01RM40.85				
Comment Code					
Inspector Comment					
09/13/2017: No significant change observed.					
07/25/2016: No significant change observed.					
06/24/2015: No significant change observed.					
06/19/2014: No significant change observed.					
08/13/2013: The erosion was discovered during 2013 spring levee inspection. Inspector comment: Erosion is located along the lower level of water-ward slope. [2017 Site ID:RD0524U01RM40.85]

Close view of the erosion.

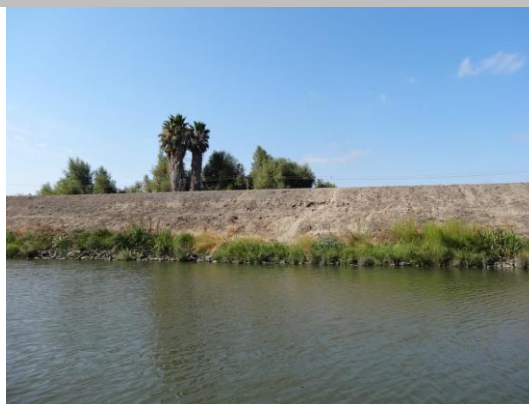
Photo 3 of 3 : SP_2019_RD0524_107_1_20190313_00003.jpg

Front view of the erosion.

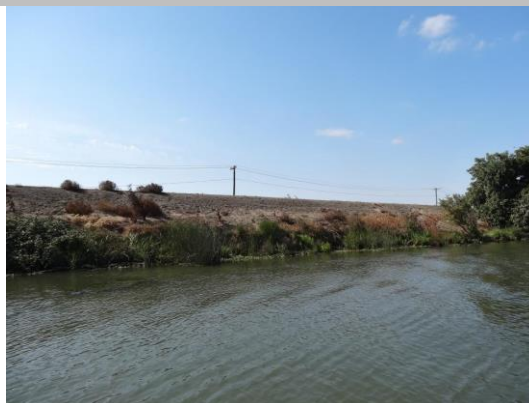
Photo 2 of 4 : SP_2019_RD0524_107_2_20190313_00005.jpg

Looking downstream of the erosion.

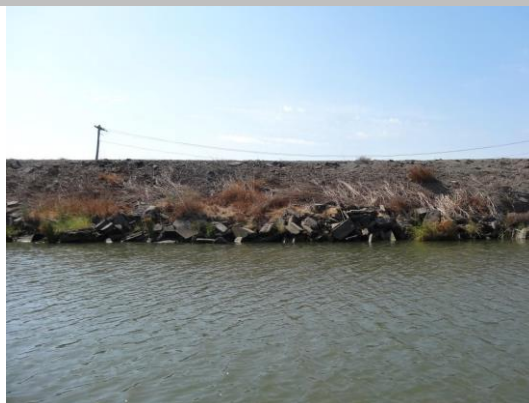
Photo 1 of 4 : SP_2019_RD0524_107_5_20190313_00008.jpg

LM Start	0.40	Rating **	M	Issue No.	5
LM End	0.40	Issue Type +	Ma	Location *	WS
Category	Supplemental			GPS Latitude/Longitude	
				Start	End
Item	DWR Erosion Survey			37.938870 °	37.938870 °
				-121.340460 °	-121.340460 °
DWR ID	RD0524U01RM40.99				
Comment Code					
Inspector Comment					
09/13/2017: No significant change observed.					
07/25/2016: More vegetation observed at the site.					
06/24/2015: No significant change observed.					
06/19/2014: No significant change observed.					
08/13/2013: No significant change at this site.					
08/07/2012: The erosion is at the upper levee slope, and likely caused by slope slip. The lower levee slope is covered with dense vegetation.					
[2017 Site ID:RD0524U01RM40.99]

Front view of the erosion site.

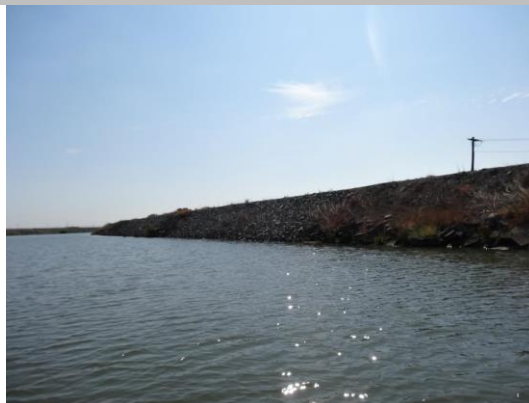
Photo 2 of 4 : SP_2019_RD0524_107_5_20190313_00009.jpg

Downstream view of the site.

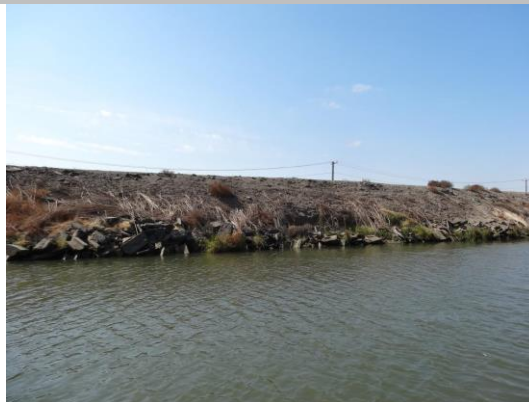
Photo 3 of 4 : SP_2019_RD0524_107_5_20190313_00010.jpg

Close view of the erosion.

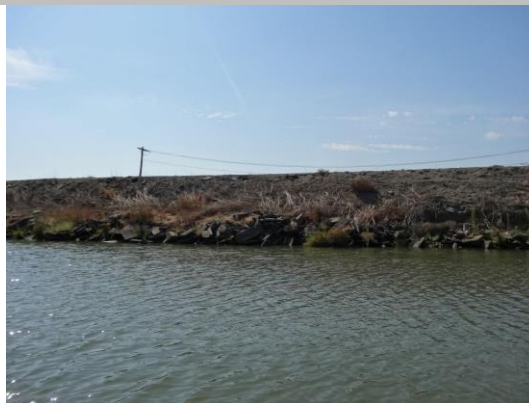
Photo 4 of 4 : SP_2019_RD0524_107_5_20190313_00011.jpg

Close view of the erosion.

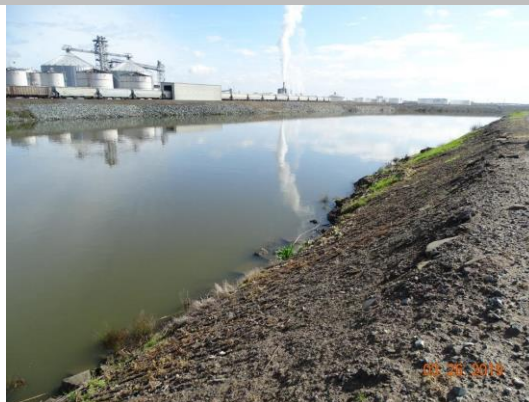
Photo 1 of 3 : SP_2019_RD0524_107_170_20190328_00391.jpg

LM Start	0.43	Rating **	M	Issue No.	170
LM End	0.43	Issue Type +	Ma	Location *	WS
Category	Earthen Levee			GPS Latitude/Longitude	
				Start	End
Item	Erosion / Bank Caving			37.938669 °	37.938669 °
				-121.340006 °	-121.340006 °
DWR ID	DWR_RD0524_01_s_2015_170				
Comment Code					
E2 : Schedule repair of erosion site prior to the next inspection.					
Inspector Comment					
Erosion on waterside toe, exposed area does not have rip rap

Erosion on waterside toe, there is no visible rip rap, taken looking upstream. Spring 2019.

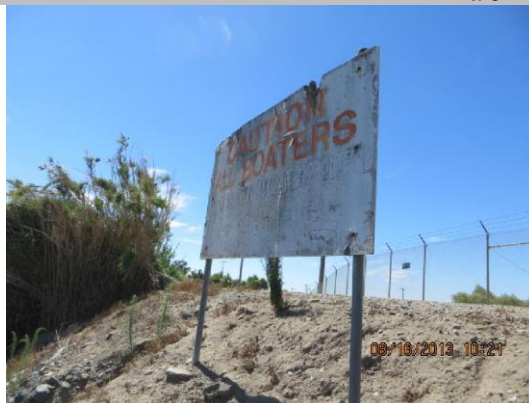
Photo 1 of 3 : UCIP_SP_2019_17563_29702.jpg

LM Start	0.67	Rating **	M	Issue No.	933
LM End	0.67	Issue Type +	En	Location *	
Category	Supplemental			GPS Latitude/Longitude	
				Start	End
Item	DWR UCIP Field Study			37.937891 °	37.937891 °
				-121.335939 °	-121.335939 °
DWR ID	20592				
Comment Code					
Inspector Comment					
FS_ID:17563 DS_ID:20592 EP_NO: 6035 Repair Type: Non-Urgent Crossing Status: Found UCIP Comments: Flows from primer tank causing erosion on LS slope. FIELD_STRUCT_DESC: 48-inch coated steel sewer pipe through the levee, 7.3 feet below the crown. Siphon pumps and primer tank enclosed by cyclone fence on the landside (LS) shoulder. Gate valve at inlet sump 100 feet off the LS toe. One concrete cutoff wall. (Permit No. 6035, 1968 - City of Stockton). [Additional Reference(s): DWR Levee Log, 2004]. FS Date: 8/16/2013

Signage for effluent pipe on WS shoulder.

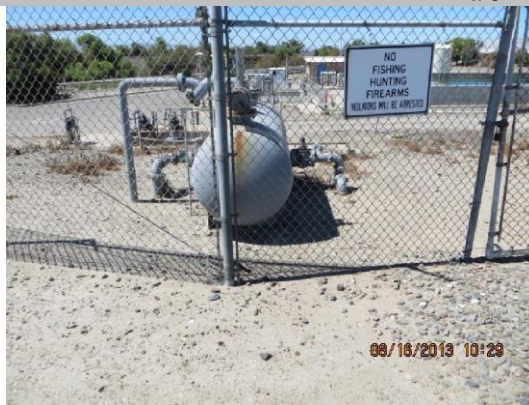
Photo 2 of 3 : UCIP_SP_2019_17563_29701.jpg

Siphon Priming tank and associated pipes on LS shoulder.

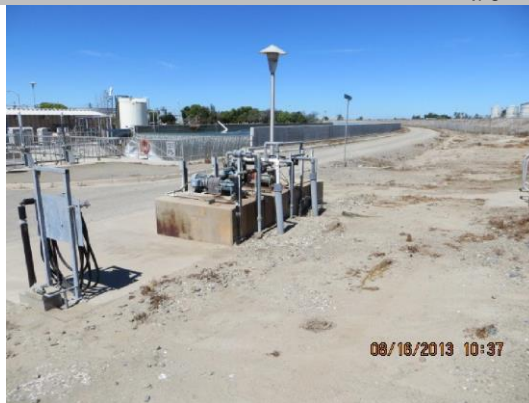
Photo 3 of 3 : UCIP_SP_2019_17563_29700.jpg

Vacuum pumps off LS toe.

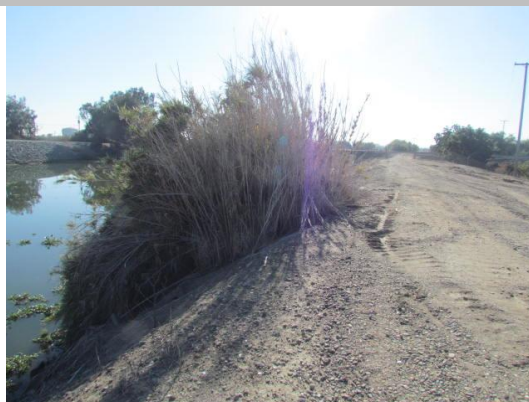
Photo 1 of 1 : SP_2019_RD0524_107_14_20190313_00016.jpg

LM Start	0.67	Rating **	U	Issue No.	14
LM End	0.67	Issue Type +	Ma	Location *	WS
Category	Earthen Levee			GPS Latitude/Longitude	
				Start	End
Item	Vegetation			37.937808 °	37.937808 °
				-121.335913 °	-121.335913 °
DWR ID	DWR_RD0524_01_s_2012_14				
Comment Code					
V2 : Remove the wild growth other than native grasses from the levee slopes.					
Inspector Comment					
Arundo on waterside slope

Looking south at dying bamboo on waterward slope. Fall 2015

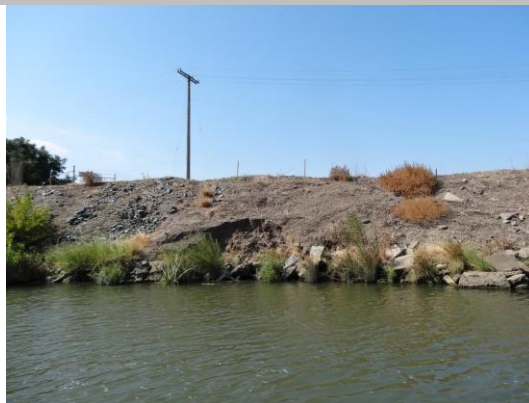
Photo 1 of 4 : SP_2019_RD0524_107_16_20190313_00019.jpg

LM Start	0.70	Rating **	M	Issue No.	16
LM End	0.70	Issue Type +	Ma	Location *	WS
Category	Supplemental			GPS Latitude/Longitude	
				Start	End
Item	DWR Erosion Survey			37.937577 °	37.937577 °
				-121.335491 °	-121.335491 °
DWR ID	RD0524U01RM41.34				
Comment Code					
Inspector Comment					
09/13/2017: Pocket erosion above the protected levee toe. [2017 Site ID:RD0524U01RM41.34]

Front view of the erosion.

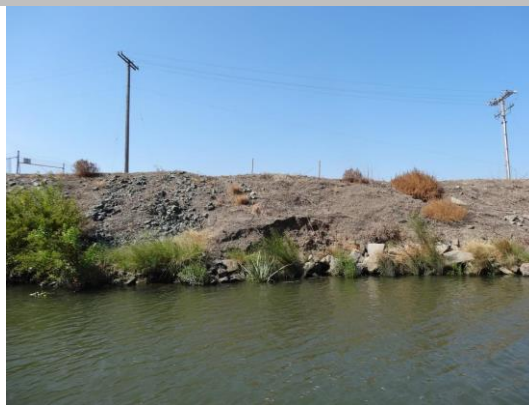
Photo 2 of 4 : SP_2019_RD0524_107_16_20190313_00020.jpg

Close view of the erosion.

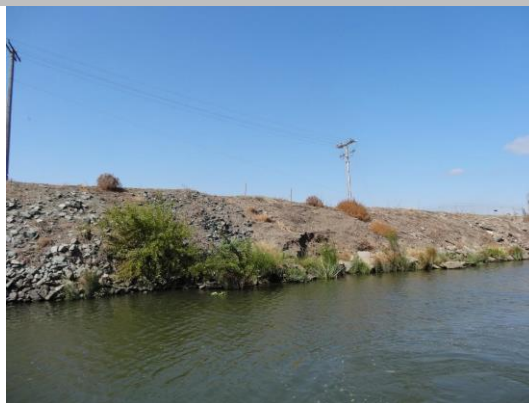
Photo 3 of 4 : SP_2019_RD0524_107_16_20190313_00021.jpg

Looking downstream of the erosion site.

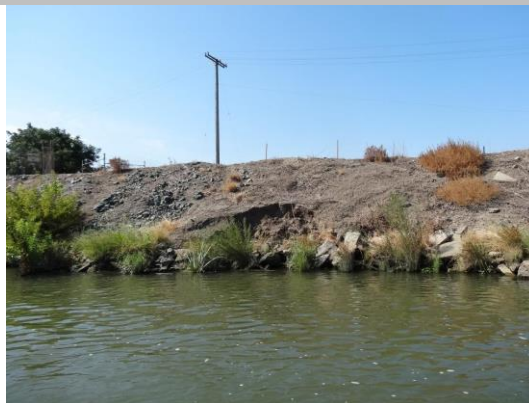
Photo 4 of 4 : SP_2019_RD0524_107_16_20190313_00022.jpg

Close view of the erosion.

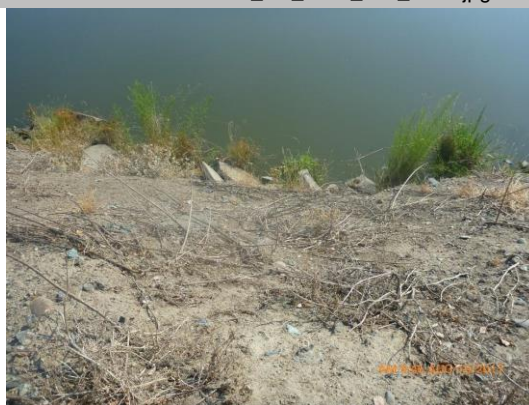
Photo 1 of 3 : LEVAL_SP_2019_541_4079.jpg

LM Start	0.70	Rating **	A/W	Issue No.	153
LM End	0.70	Issue Type +	Ma	Location *	
Category	Supplemental			GPS Latitude/Longitude	
				Start	End
Item	2017 Storm Damage			37.937500 °	37.937500 °
				-121.335500 °	-121.335500 °
DWR ID	DWR_RD0524_01_f_2017_153				
Comment Code					
Inspector Comment					
Levee Evaluation Comments					
Description:Slope protection repairs are needed along the waterside slope due to erosion and riprap displacement from high water. Based upon levee inspections, it was determined the waterside levee slope is eroding, deteriorating, and degrading. The eroded levee sections need to be restored back to design standards to prevent further deterioration and damage.					
Site ID No:541					
Site Designation:LMA-447					
Repair Type: Erosion					
Rating:Area of Concern					
Field Date:8/10/2017					
Notes:

Item	2017 Storm Damage		37.937500 °	37.937500 °								
			-121.335500 °	-121.335500 °								
DWR ID	DWR_RD0524_01_f_2017_153											
Comment Code												
Inspector Comment												
<p>Levee Evaluation Comments</p> <p>Description: Slope protection repairs are needed along the waterside slope due to erosion and riprap displacement from high water. Based upon levee inspections, it was determined the waterside levee slope is eroding, deteriorating, and degrading. The eroded levee sections need to be restored back to design standards to prevent further deterioration and damage.</p> <p>Site ID No: 541</p> <p>Site Designation: LMA-447</p> <p>Repair Type: Erosion</p> <p>Rating: Area of Concern</p> <p>Field Date: 8/10/2017</p> <p>Notes:</p>

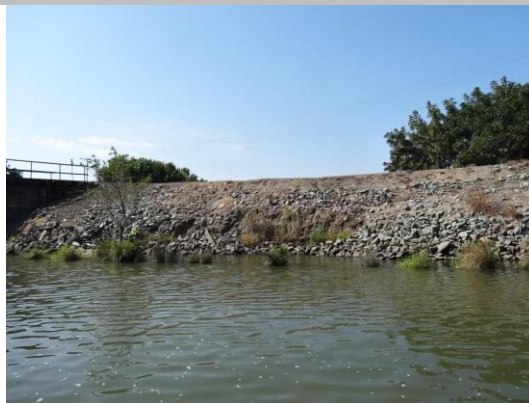
Photo 1 of 3 : SP_2019_RD0524_107_17_20190313_00023.jpg

LM Start	0.71	Rating **	M	Issue No.	17
LM End	0.73	Issue Type +	Ma	Location *	WS
Category	Supplemental			GPS Latitude/Longitude	
				Start	End
Item	DWR Erosion Survey			37.937222 °	37.937222 °
				-121.335277 °	-121.335277 °
DWR ID	RD0524U01RM41.36				
Comment Code					
Inspector Comment					
09/13/2017: No significant change observed.					
07/25/2016: No significant change observed.					
06/24/2015: The erosion site is immediately downstream of the RR bridge. [2017 Site ID:RD0524U01RM41.36]

Front view of the erosion.

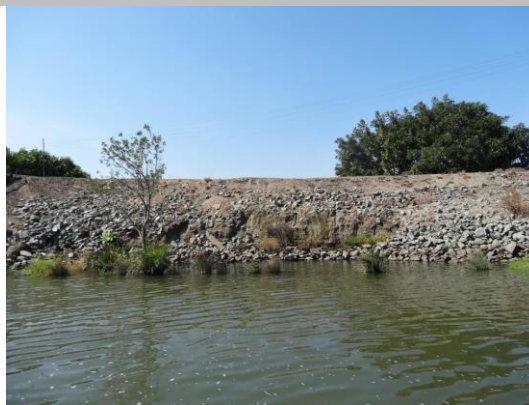
Photo 2 of 3 : SP_2019_RD0524_107_17_20190313_00024.jpg

LM Start	0.71	Rating **	M	Issue No.	17 (cont)
LM End	0.73	Issue Type +	Ma	Location *	WS

Close view of the erosion.

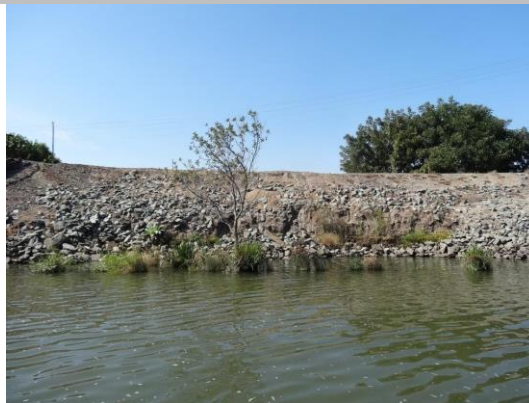
Photo 3 of 3 : SP_2019_RD0524_107_17_20190313_00025.jpg

LM Start	0.71	Rating **	M	Issue No.	17 (cont)
LM End	0.73	Issue Type +	Ma	Location *	WS

Close view of the erosion.

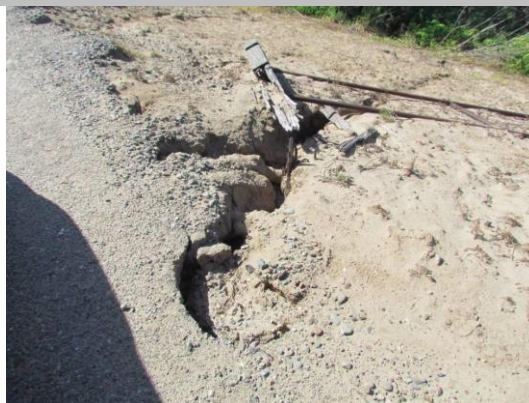
Photo 2 of 2 : SP_2019_RD0524_107_157_20190313_00167.jpg

LM Start	0.72	Rating **	M	Issue No.	157
LM End	0.72	Issue Type +	Ma	Location *	LS
Category	Earthen Levee			GPS Latitude/Longitude	
				Start	End
Item	Erosion / Bank Caving			37.937290 °	37.937290 °
				-121.335417 °	-121.335417 °
DWR ID	DWR_RD0524_01_s_2017_157				
Comment Code					
E2 : Schedule repair of erosion site prior to the next inspection.					
Inspector Comment					
Slope damage caused by rain runoff on landside slope.

Looking south at slope damage caused by rain runoff on landward slope.

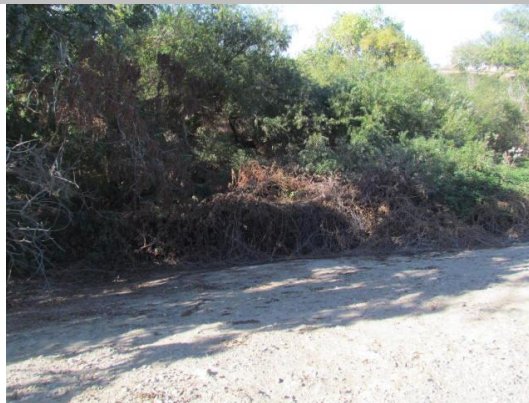
Photo 3 of 3 : SP_2019_RD0524_107_262_20190313_00274.jpg

Looking west at dense vegetation on landside toe. Spring 2014

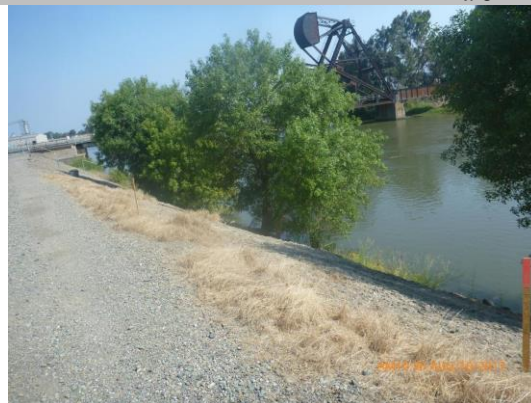
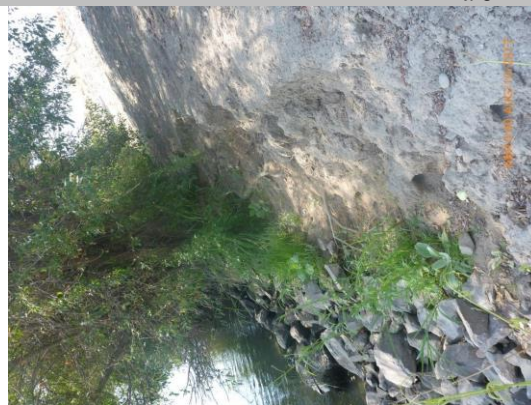
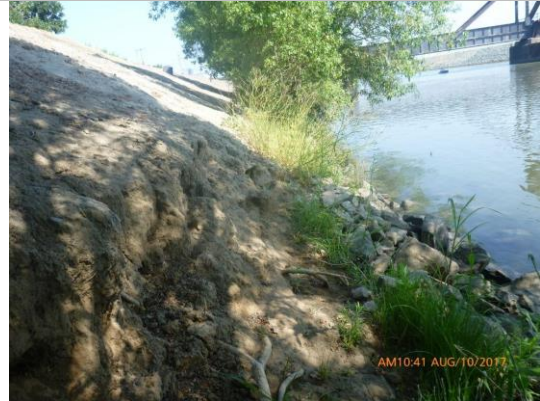
LM Start	0.79	Rating **	A/W	Issue No.	155
LM End	0.80	Issue Type +	Ma	Location *	WS
Category	Supplemental			GPS Latitude/Longitude	
				Start	End
Item	2017 Storm Damage			37.936300 °	37.936200 °
				-121.334700 °	-121.334600 °
DWR ID	DWR_RD0524_01_f_2017_155				
Comment Code					
Inspector Comment					
Levee Evaluation Comments					
Description:Slope protection repairs are needed along the waterside slope due to erosion and riprap displacement from high water. Based upon levee inspections, it was determined the waterside levee slope is eroding, deteriorating, and degrading. The eroded levee sections need to be restored back to design standards to prevent further deterioration and damage.					
Site ID No:538					
Site Designation:LMA-444					
Repair Type: Erosion					
Rating:Area of Concern					
Field Date:8/10/2017					
Notes:

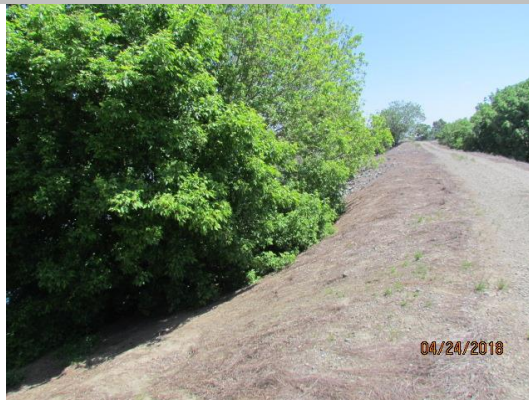
Photo 1 of 1 : SP_2019_RD0524_107_149_20190313_00149.jpg

LM Start	0.90	Rating **	M	Issue No.	149
LM End	0.90	Issue Type +	Ma	Location *	WS
Category	Earthen Levee			GPS Latitude/Longitude	
				Start	End
Item	Trim / Thin Trees			37.935319 °	37.935319 °
				-121.333406 °	-121.333406 °
DWR ID	DWR_RD0524_01_s_2018_149				
Comment Code					
T1 : Trim trees to at least five feet above ground level.					
Inspector Comment

Looking southeast at untrimmed trees on waterward slope. (Spring 2018)

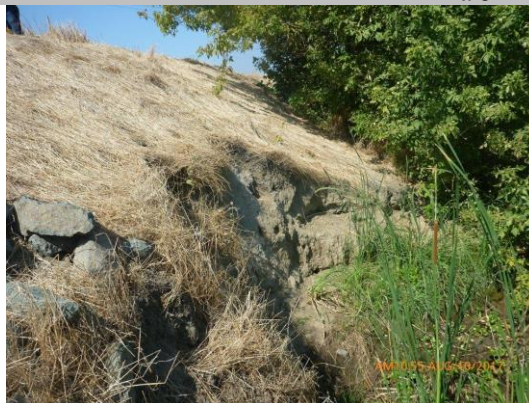
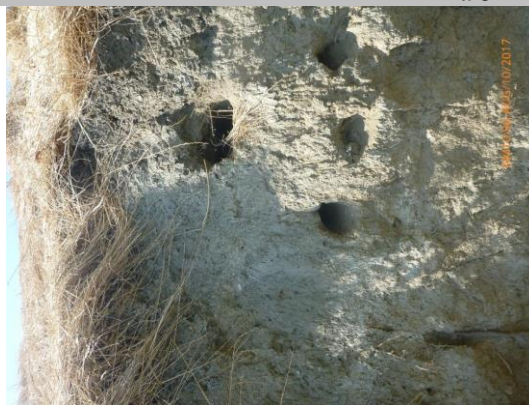
LM Start	0.90	Rating **	A/W	Issue No.	193
LM End	0.91	Issue Type +	Ma	Location *	
Category	Supplemental			GPS Latitude/Longitude	
				Start	End
Item	2017 Storm Damage			37.935400 °	37.935300 °
				-121.333300 °	-121.333200 °
DWR ID	DWR_RD0524_01_f _ 2017_193				
Comment Code					
Inspector Comment					
Levee Evaluation Comments					
Description:Slope protection repairs are needed along the waterside slope due to erosion and riprap displacement from high water. Based upon levee inspections, it was determined the waterside levee slope is eroding, deteriorating, and degrading. The eroded levee sections need to be restored back to design standards to prevent further deterioration and damage.					
Site ID No:537					
Site Designation:LMA-443					
Repair Type: Erosion					
Rating:Serious					
Field Date:8/10/2017					
Notes:

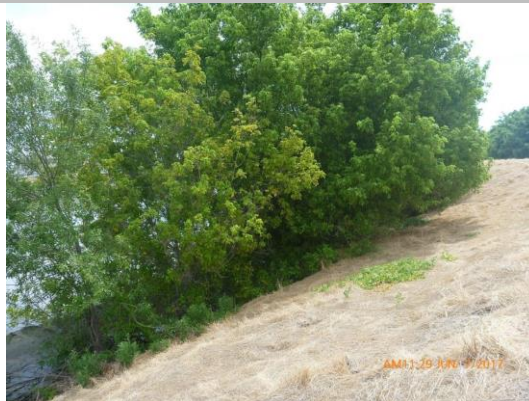
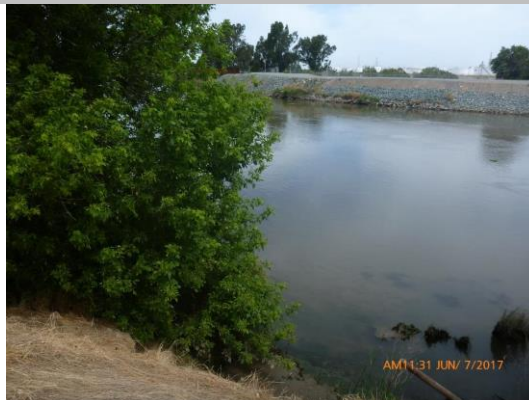
LM Start	0.91	Rating **	A/W	Issue No.	187 (cont)	
LM End		Issue Type +	Ma	Location *		
Category	Supplemental			GPS Latitude/Longitude		
				Start	End	
Item	2017 Storm Damage			37.935580 °		°
				-121.333200 °		°
DWR ID	DWR_RD0524_01_f_2017_187					
Comment Code						
Inspector Comment						
Levee Evaluation Comments						
Description:						
Site ID No:87						
Site Designation:DWR_RD0524_01_s_2012_99						
Repair Type: Erosion						
Rating:Area of Concern						
Field Date:6/7/2017						
Notes: no observable defects to levee, vegetation blocks ws toe

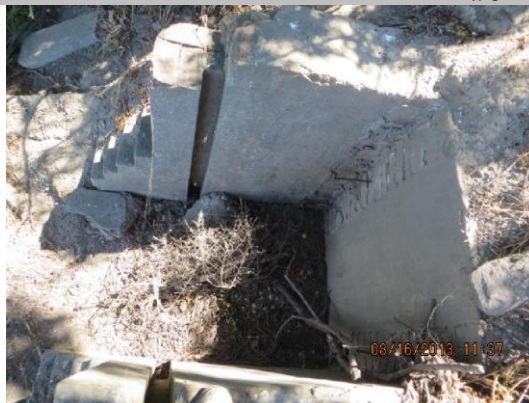
Photo 2 of 2 : UCIP_SP_2019_17575_29735.jpg

LM Start	0.98	Rating **	A/W	Issue No.	937 (cont)	
LM End	0.98	Issue Type +	Ma	Location *		
Category	Supplemental			GPS Latitude/Longitude		
				Start		End
Item	DWR UCIP LMA Responsibility			37.935163 °		37.935163 °
				-121.331887 °		-121.331887 °
DWR ID	20598					
Comment Code						
Inspector Comment						
FS_ID:17575 DS_ID:20598 EP_NO: N/A Repair Type: No Action Needed Crossing Status: Found UCIP Comments: FIELD_STRUCT_DESC: *ABANDONED* 36-inch drainage pipe of an unknown material through the levee, 15 feet below the crown. Landside (LS) end is not visible. Concrete headwall at outlet on the waterside (WS) slope is visible. Pipe appears to be abandoned in place. Slide gate on the WS removed. [Additional Reference(s): DWR Levee Log, 2004. USACE San Joaquin O&M Manual 7, April 1964, (HLM 0.99)]. FS Date: 8/16/2013

Slide gate removed from headwall on WS slope.

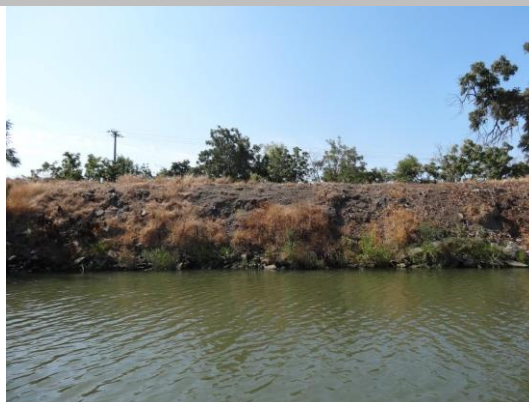
Photo 1 of 4 : SP_2019_RD0524_107_30_20190313_00047.jpg

LM Start	1.00	Rating **	U	Issue No.	30
LM End	1.00	Issue Type +	Ma	Location *	WS
Category	Supplemental			GPS Latitude/Longitude	
				Start	End
Item	DWR Erosion Survey			37.935410 °	37.935410 °
				-121.331560 °	-121.331560 °
DWR ID	RD0524U01RM41.58				
Comment Code					
Inspector Comment					
09/13/2017: No significant change observed.					
07/25/2016: No significant change observed.					
06/24/2015: No significant change observed.					
06/19/2014: No significant change observed.					
08/13/2013: No significant change at this site.					
08/07/2012: The erosion was discovered during the boat survey. [2017					
Site ID:RD0524U01RM41.58]

Front view of the erosion.

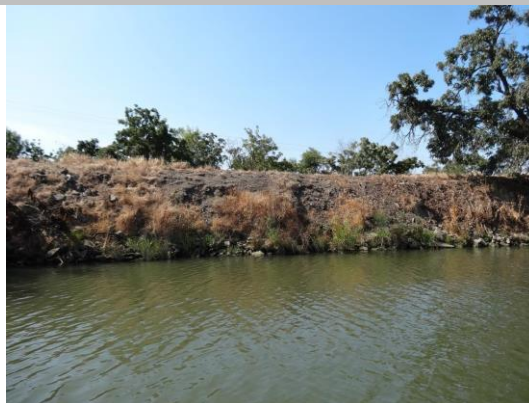
Photo 2 of 4 : SP_2019_RD0524_107_30_20190313_00048.jpg

Close view of the erosion.

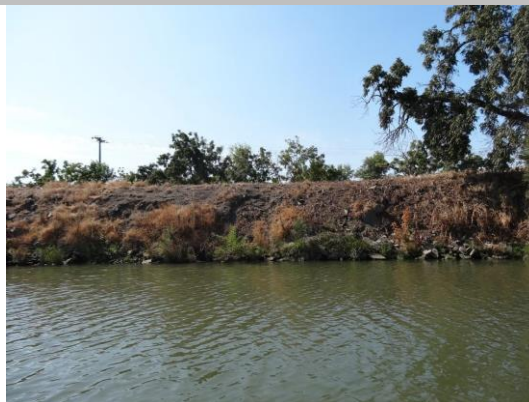
Photo 3 of 4 : SP_2019_RD0524_107_30_20190313_00049.jpg

Front view of the erosion.

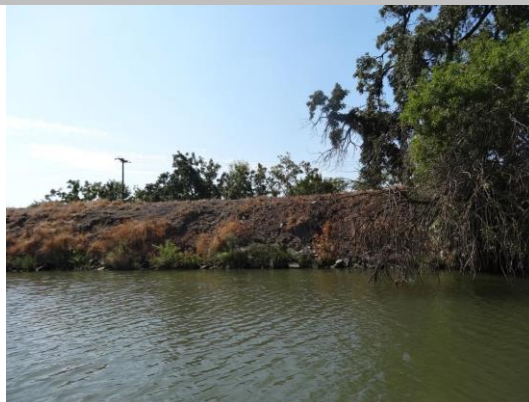
Photo 4 of 4 : SP_2019_RD0524_107_30_20190313_00050.jpg

Downstream view of the erosion.

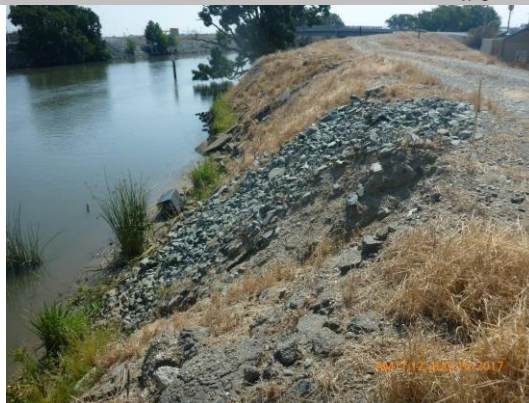
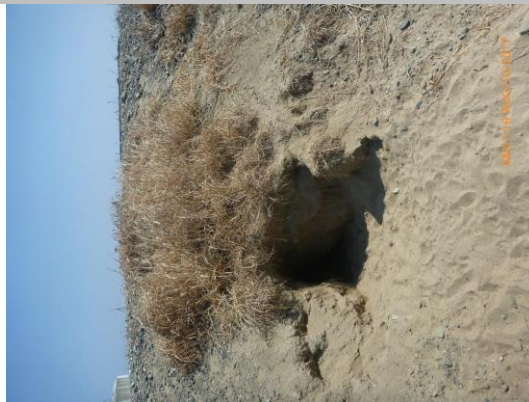
Comment Code					
Inspector Comment					
Levee Evaluation Comments					
Description:Slope protection repairs are needed along the waterside slope due to erosion and riprap displacement from high water. Based upon levee inspections, it was determined the waterside levee slope is eroding, deteriorating, and degrading. The eroded levee sections need to be restored back to design standards to prevent further deterioration and damage.					
Site ID No:536					
Site Designation:LMA-442					
Repair Type: Erosion					
Rating:Area of Concern					
Field Date:8/10/2017					
Notes: Appears to be previous repair site adjacent to LMA-442. Large fox den on land side

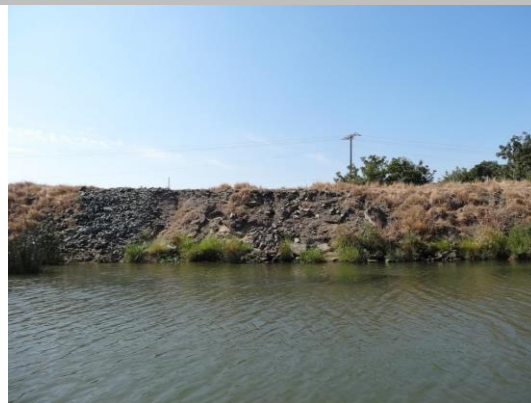
Photo 2 of 3 : SP_2019_RD0524_107_33_20190313_00052.jpg

Comment Code						
Inspector Comment						
09/13/2017: No significant change observed.						
07/25/2016: No significant change observed.						
06/24/2015: No significant change observed.						
06/19/2014: No significant change observed.						
08/13/2013: No significant change at this site.						
08/07/2012: The site has been visited by boat survey. Site has been repaired, but new erosion occurred at the levee slope and immediately upstream of the repaired site.						
08/23/2011: The site is about 500 ft downstream of bridge. The levee toe seems to be protected, but the protection is being washed away.						
[2017 Site ID:RD0524U01RM41.59]

Close view of the erosion.

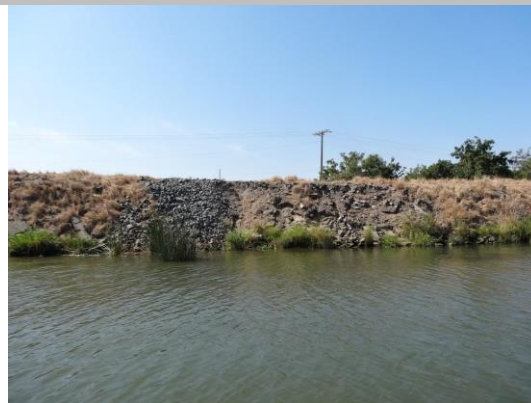
Photo 3 of 3 : SP_2019_RD0524_107_33_20190313_00053.jpg

Front view of the site.

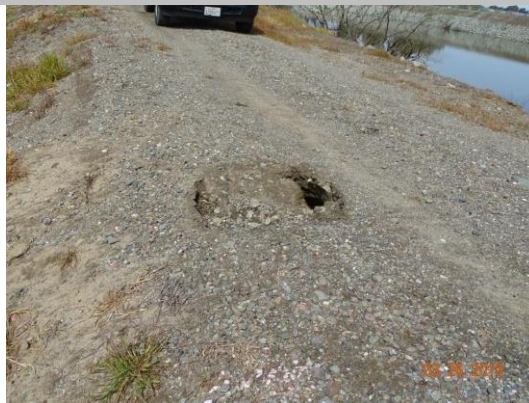
Photo 1 of 3 : SP_2019_RD0524_107_238_20190328_00392.jpg

LM Start	1.02	Rating **	U	Issue No.	238
LM End	1.02	Issue Type +	Ma	Location *	LS
Category	Earthen Levee			GPS Latitude/Longitude	
				Start	End
Item	Animal Control			37.934991 °	37.934991 °
				-121.331160 °	-121.331160 °
DWR ID	DWR_RD0524_01_f_2017_238				
Comment Code					
A3 : No rodents visible, but rodent burrows visible; need to backfill and compact or grout burrows.					
Inspector Comment					
Multiple large rodent holes on landward slope and toe. Large hole on crown near landside shoulder

Large rodent hole landside shoulder looking downstream. Spring 2019.

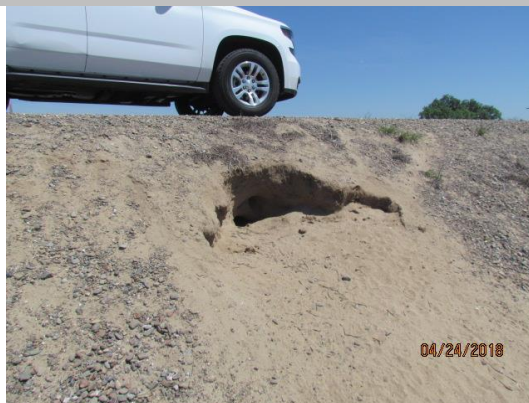
Photo 2 of 3 : SP_2019_RD0524_107_238_20190313_00259.jpg

Looking east at large rodent hole on landward slope. (Spring 2018)

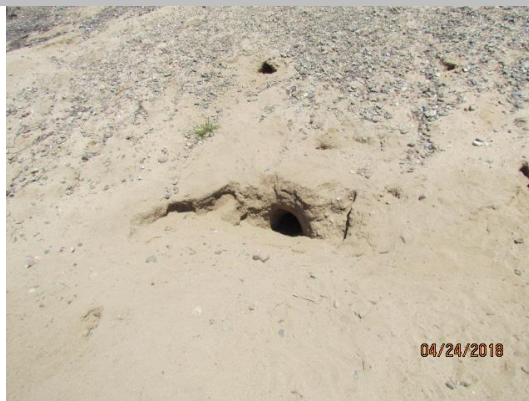
Photo 3 of 3 : SP_2019_RD0524_107_238_20190313_00260.jpg

Looking northeast at rodent hole on landward slope. (Spring 2018)

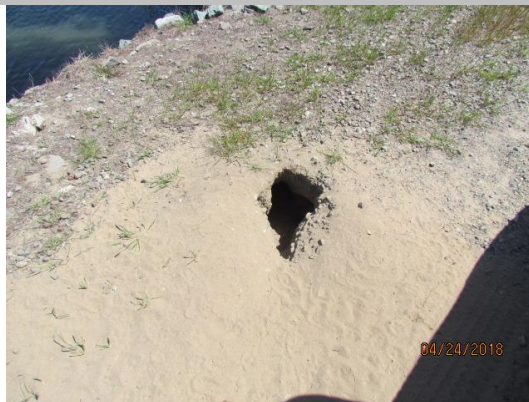
Photo 1 of 3 : SP_2019_RD0524_107_150_20190313_00150.jpg

LM Start	1.04	Rating **	U	Issue No.	150
LM End	1.04	Issue Type +	Ma	Location *	WS
Category	Earthen Levee		GPS Latitude/Longitude		
			Start	End	
Item	Animal Control		37.934896 °	37.934896 °	
			-121.330781 °	-121.330781 °	
DWR ID	DWR_RD0524_01_s_2018_150				
Comment Code					
Inspector Comment					
A3 : No rodents visible, but rodent burrows visible; need to backfill and compact or grout burrows.					
Large rodent hole on waterward shoulder and crown of levee.

Looking at close-up view of rodent hole on waterward shoulder. (Spring 2018)

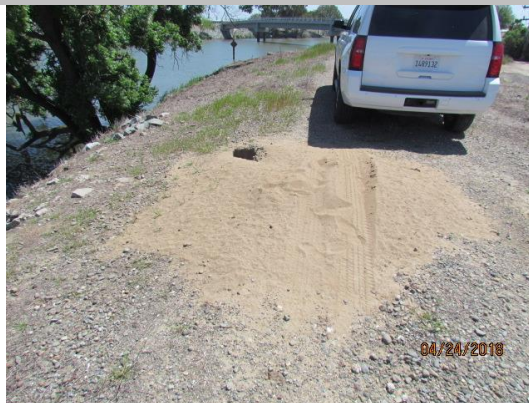
Photo 2 of 3 : SP_2019_RD0524_107_150_20190313_00151.jpg

Looking south at large rodent hole on waterward shoulder. (Spring 2018)

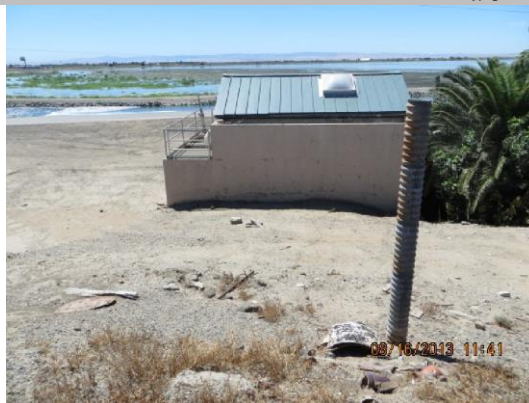
Photo 1 of 2 : UCIP_SP_2019_18703_31243.jpg

Comment Code					
Inspector Comment					
FS_ID:18703 DS_ID:20600 EP_NO: 2725B Repair Type: Non-Urgent Crossing Status: Found UCIP Comments: Given amount of rust on adjacent CMP riser, it may be appropriate to do a video inspection of this pipe. FIELD_STRUCT_DESC: 36-inch concrete encased sewer pipe through the levee, 11.5 feet below the crown. Pump in pump house on the landside (LS). Flap gate on the waterside (WS) end. Two concrete cutoff walls. Siphon breaker in 8-inch corrugated metal riser unit on the LS slope. (Permit No. 2725-B, 1959 - City of Stockton). [Additional Reference(s): DWR Levee Log, 2004. USACE San Joaquin O&M Manual 7, April 1964, (HLM 1.08)]. FS Date: 8/16/2013

8-inch CMP standpipe on LS slope with pumphouse in background.

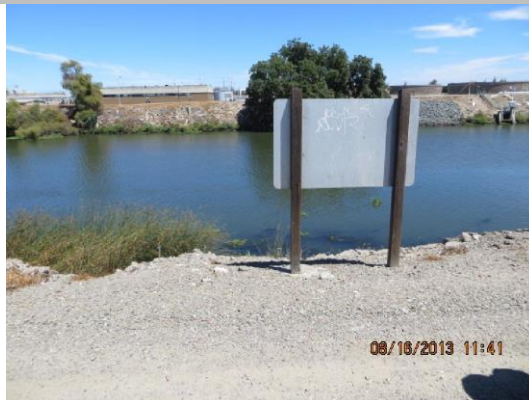
Photo 2 of 2 : UCIP_SP_2019_18703_31242.jpg

Caution sign on WS shoulder for pipe crossings.

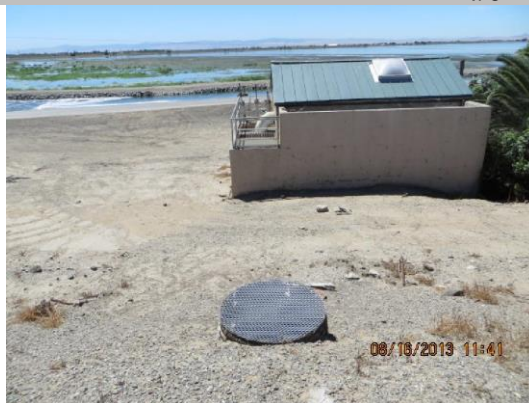
Photo 1 of 3 : UCIP_SP_2019_17589_29748.jpg

Comment Code						
Inspector Comment						
FS_ID:17589						
DS_ID:20601						
EP_NO: 2725B						
Repair Type: Non-Urgent						
Crossing Status: Found						
UCIP Comments: CMP riser severely corroded. Good indicator of potential condition of 48-inch pipe. Recommend Video Inspection.						
FIELD_STRUCT_DESC: 48-inch corrugated metal sewer line through the levee, 16 feet below the crown. Runs underneath the river and through the levee with 36-inch corrugated metal riser unit/inspection chamber on the landside (LS) shoulder. Distribution/pump house on the LS toe. (Permit No. 2725-B, 1959 - City of Stockton). [Additional Reference(s): DWR Levee Log, 2004. USACE San Joaquin O&M Manual 7, April 1964, (HLM 1.08)].						
FS Date: 8/16/2013

CMP riser for access/inspection on LS slope with distribution/pumphouse on LS toe.

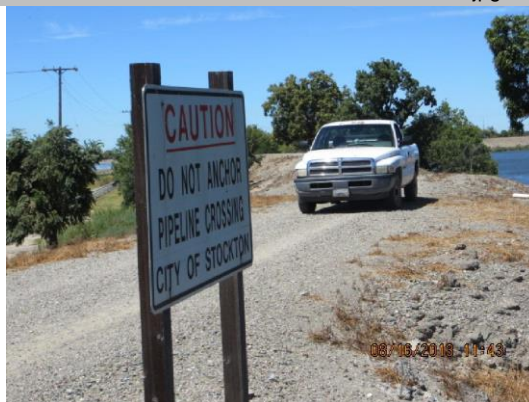
Photo 2 of 3 : UCIP_SP_2019_17589_29747.jpg

Caution sign on WS shoulder.

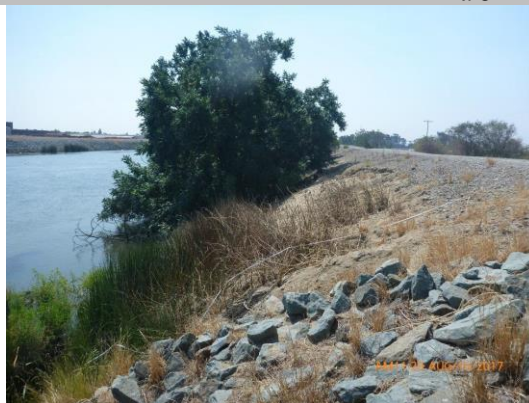
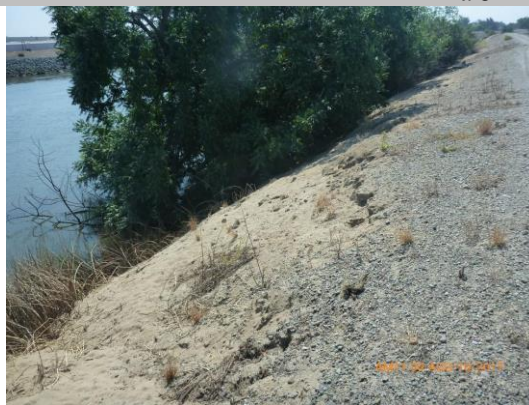
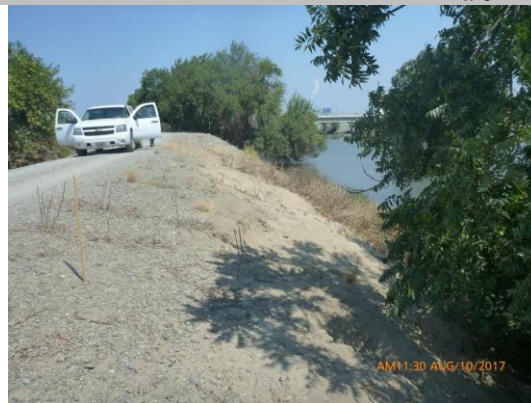
LM Start	1.18	Rating **	A/W	Issue No.	221
LM End	1.20	Issue Type +	Ma	Location *	
Category	Supplemental			GPS Latitude/Longitude	
				Start	End
Item	2017 Storm Damage			37.933500 °	37.933200 °
				-121.329100 °	-121.328900 °
DWR ID	DWR_RD0524_01_f_2017_221				
Comment Code					
Inspector Comment					
Levee Evaluation Comments					
Description:Slope protection repairs are needed along the waterside slope due to erosion and riprap displacement from high water. Based upon levee inspections, it was determined the waterside levee slope is eroding, deteriorating, and degrading. The eroded levee sections need to be restored back to design standards to prevent further deterioration and damage.					
Site ID No:535					
Site Designation:LMA-441					
Repair Type: Erosion					
Rating:Area of Concern					
Field Date:8/10/2017					
Notes:

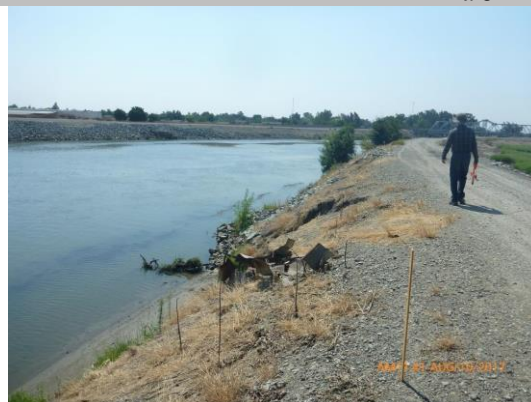
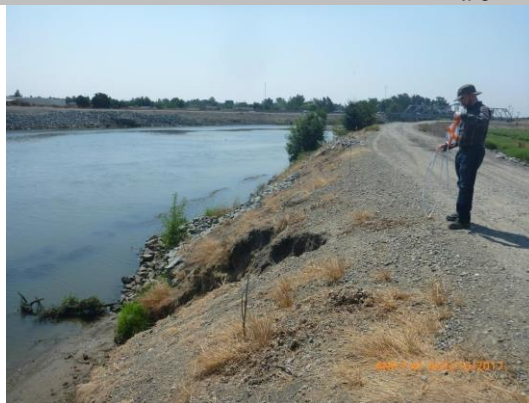
Comment Code					
Inspector Comment					
Levee Evaluation Comments					
Description:Slope protection repairs are needed along the waterside slope due to erosion and riprap displacement from high water. Based upon levee inspections, it was determined the waterside levee slope is eroding, deteriorating, and degrading. The eroded levee sections need to be restored back to design standards to prevent further deterioration and damage.					
Site ID No:534					
Site Designation:LMA-440					
Repair Type: Erosion					
Rating:Serious					
Field Date:8/10/2017					
Notes: site is related to, but not combined with, LMA-439 a portion of this site has been repaired.

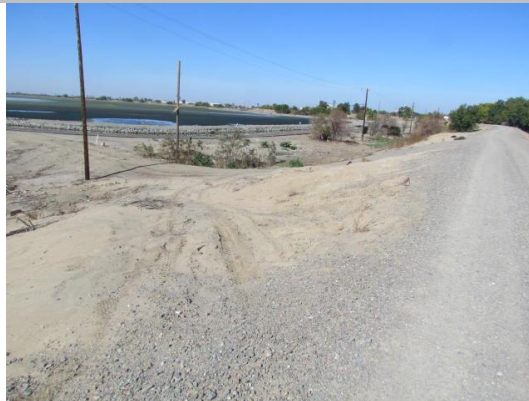
Photo 1 of 2 : SP_2019_RD0524_107_263_20190313_00275.jpg

LM Start	1.25	Rating **	U	Issue No.	263
LM End	1.25	Issue Type +	En	Location *	LS
Category	Earthen Levee			GPS Latitude/Longitude	
				Start	End
Item	Encroachments			37.932533 °	37.932533 °
				-121.328650 °	-121.328650 °
DWR ID	DWR_RD0524_01_s_2012_263				
Comment Code					
RA : Ramp					
Inspector Comment					
Unauthorized ramps on landside slope. Ramps were caused by vehicle traffic.

Looking northwest at unauthorized ramp on landside slope.

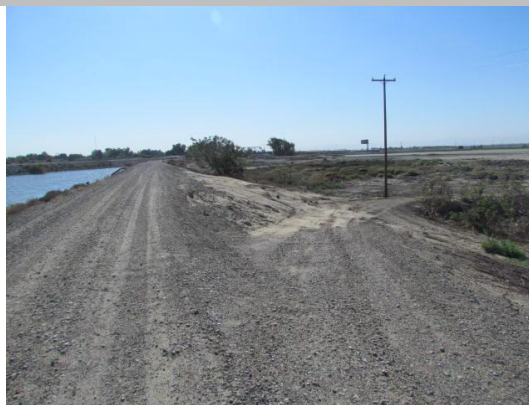
Photo 2 of 2 : SP_2019_RD0524_107_263_20190313_00276.jpg

Looking south at unauthorized ramp on landside slope.

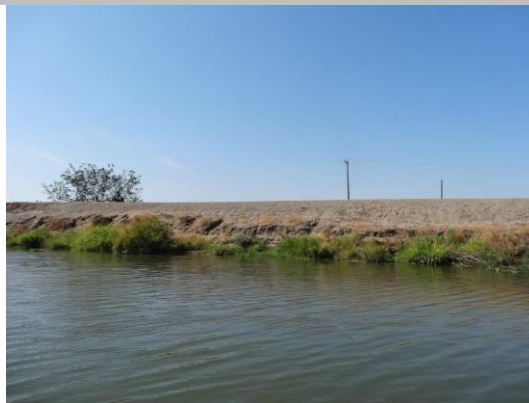
Photo 1 of 4 : SP_2019_RD0524_107_47_20190313_00066.jpg

LM Start	1.27	Rating **	A/W	Issue No.	47
LM End	1.30	Issue Type +	Ma	Location *	WS
Category	Supplemental			GPS Latitude/Longitude	
				Start	End
Item	DWR Erosion Survey			37.931858 °	37.931887 °
				-121.328300 °	-121.328343 °
DWR ID	RD0524U01RM41.92				
Comment Code					
Inspector Comment					
5/17/2018. LM 1.30-1.31 was repaired by DWR the remainder of the site was un affected.					
09/13/2017. The erosion has developed along the levee slope. The length of the erosion is nearly doubled comparing to the prior survey.					
07/25/2016: No significant change observed.					
06/24/2015: No significant change observed.					
06/19/2014: No significant change observed.					
08/13/2013: New signs of animal activity were found.					
08/07/2012: The site was first reported in 2012 spring levee inspection report. [2017 Site ID:RD0524U01RM41.92]

Front view of the erosion.

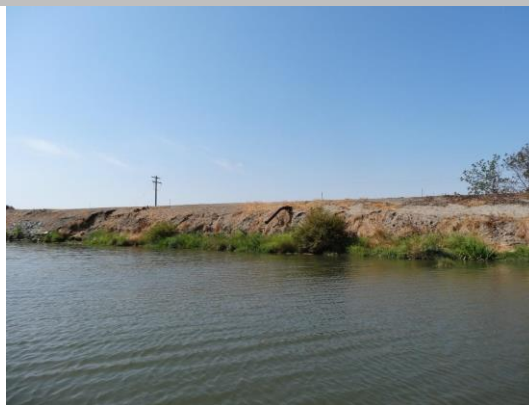
Photo 2 of 4 : SP_2019_RD0524_107_47_20190313_00067.jpg

Front view of the erosion.

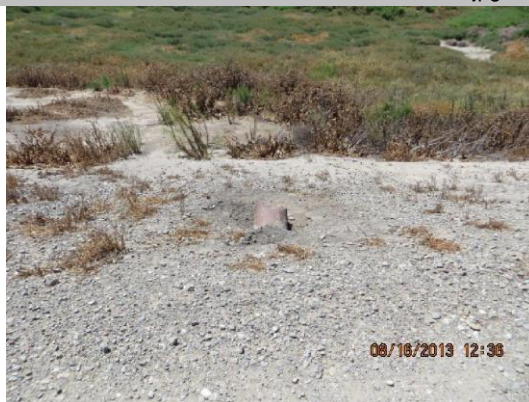
Photo 2 of 3 : UCIP_SP_2019_53162_29861.jpg

Pipe open and visible on LS slope.

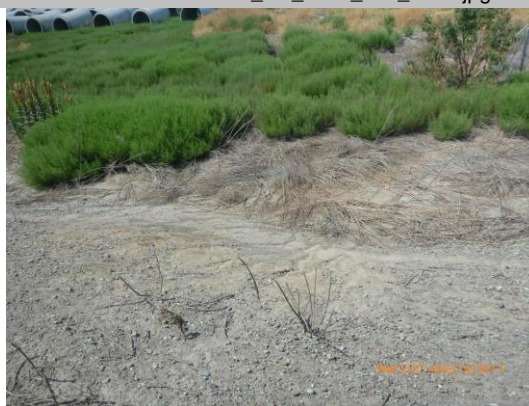
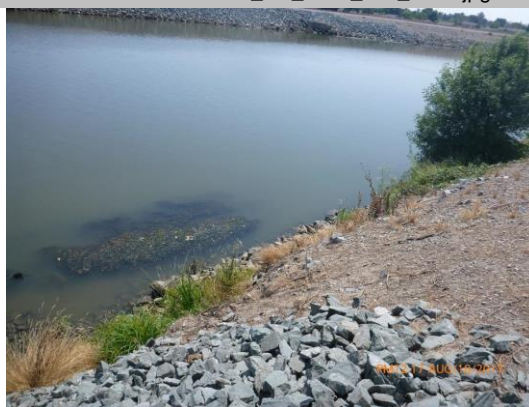
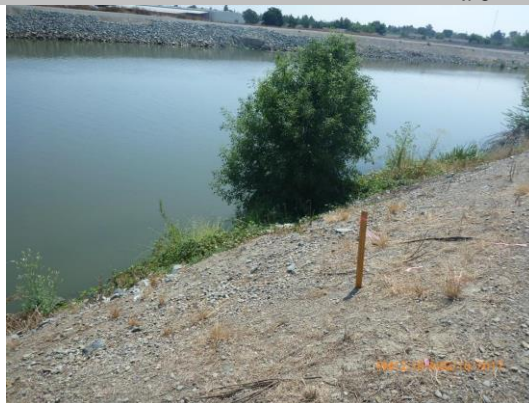
LM Start	1.33	Rating **	A/W	Issue No.	225
LM End	1.33	Issue Type +	Ma	Location *	
Category	Supplemental			GPS Latitude/Longitude	
				Start	End
Item	2017 Storm Damage			37.931500 °	37.931500 °
				-121.328200 °	-121.328200 °
DWR ID	DWR_RD0524_01_f_2017_225				
Comment Code					
Inspector Comment					
Levee Evaluation Comments					
Description:Slope protection repairs are needed along the waterside slope due to erosion and riprap displacement from high water. Based upon levee inspections, it was determined the waterside levee slope is eroding, deteriorating, and degrading. The eroded levee sections need to be restored back to design standards to prevent further deterioration and damage.					
Site ID No:532					
Site Designation:LMA-438					
Repair Type: Erosion					
Rating:Area of Concern					
Field Date:8/10/2017					
Notes:

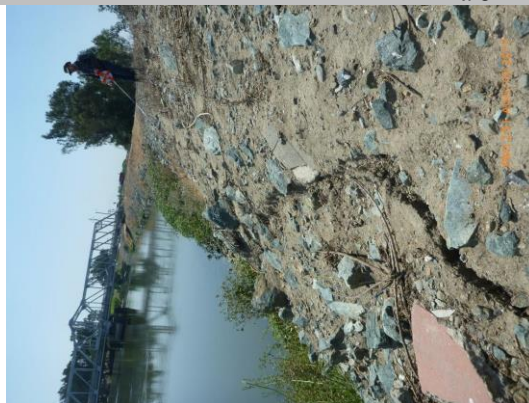
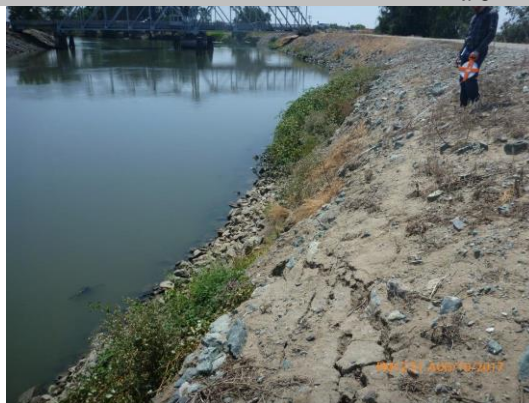
LM Start	1.43	Rating **	A/W	Issue No.	226
LM End	1.44	Issue Type +	Ma	Location *	
Category	Supplemental			GPS Latitude/Longitude	
				Start	End
Item	2017 Storm Damage			37.930100 °	37.929900 °
				-121.328300 °	-121.328300 °
DWR ID	DWR_RD0524_01_f_2017_226				
Comment Code					
Inspector Comment					
Levee Evaluation Comments					
Description:Slope protection repairs are needed along the waterside slope due to erosion and riprap displacement from high water. Based upon levee inspections, it was determined the waterside levee slope is eroding, deteriorating, and degrading. The eroded levee sections need to be restored back to design standards to prevent further deterioration and damage.					
Site ID No:530					
Site Designation:LMA-436					
Repair Type: Erosion					
Rating:Area of Concern					
Field Date:8/10/2017					
Notes:

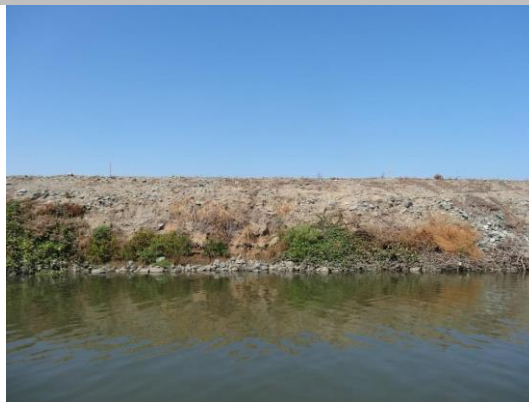
Photo 3 of 4 : SP_2019_RD0524_107_60_20190313_00085.jpg

Close view of the erosion. Note the vegetation at the site.

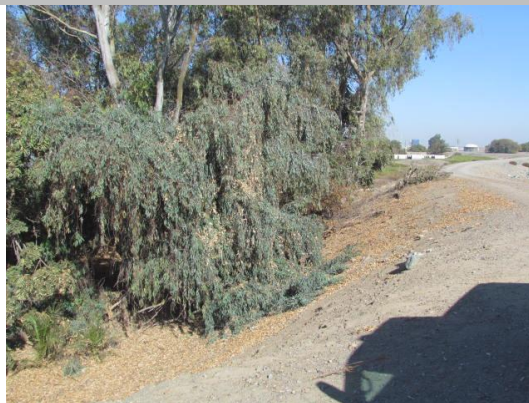
Photo 1 of 1 : SP_2019_RD0524_107_916_20190313_00285.jpg

LM Start	1.49	Rating **	U	Issue No.	916
LM End	1.49	Issue Type +	Ma	Location *	LS
Category	Earthen Levee			GPS Latitude/Longitude	
				Start	End
Item	Trim / Thin Trees			37.929118 °	37.929118 °
				-121.328368 °	-121.328368 °
DWR ID	DWR_RD0524_01_s_2012_916				
Comment Code					
T3 : Trim and thin trees to allow visibility of the ground and room to flood fight.					
Inspector Comment					
Untrimmed trees and dense vegetation on landside toe.

Looking at dense trees on landward slope and toe fall 2015

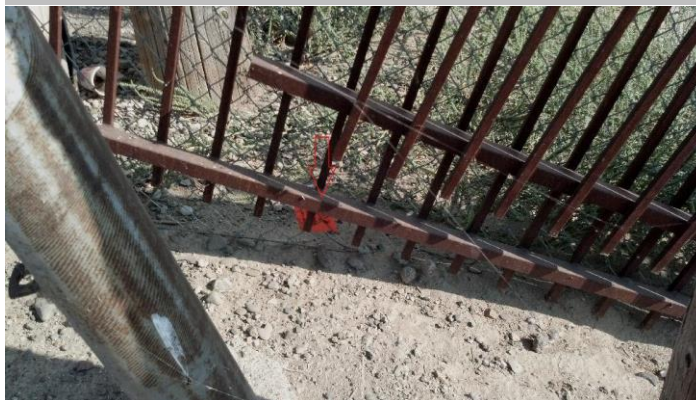
Photo 1 of 2 : UCIP_SP_2019_17798_29935.jpg

LM Start	1.54	Rating **	M	Issue No.	941
LM End	1.54	Issue Type +	En	Location *	
Category	Supplemental			GPS Latitude/Longitude	
				Start	End
Item	DWR UCIP Field Study			37.928429 °	37.928429 °
				-121.328297 °	-121.328297 °
DWR ID	20605				
Comment Code					
Inspector Comment					
FS_ID:17798 DS_ID:20605 EP_NO: N/A Repair Type: Non-Urgent Crossing Status: Indicator Found UCIP Comments: No permit identified for this crossing. FIELD_STRUCT_DESC: Fiber optics cable crossing of an unknown material. USA marker flags over crown along alignment of gate. FS Date: 8/20/2013

USAA markers along alignment at gate.

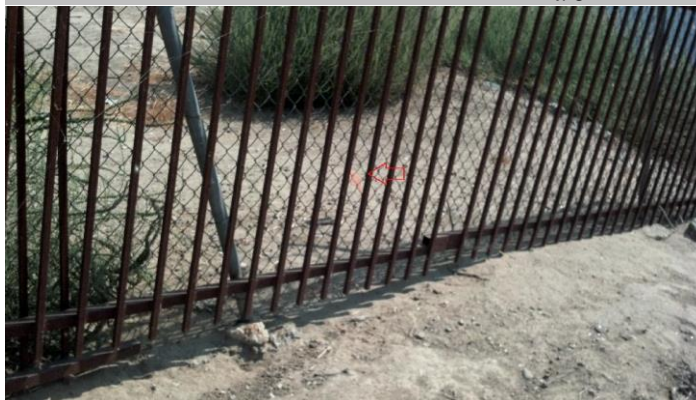
Photo 2 of 2 : UCIP_SP_2019_17798_29934.jpg

LM Start	1.54	Rating **	M	Issue No.	941 (cont)	
LM End	1.54	Issue Type +	En	Location *		
Category	Supplemental			GPS Latitude/Longitude		
				Start		End
Item	DWR UCIP Field Study			37.928429 °		37.928429 °
				-121.328297 °		-121.328297 °
DWR ID	20605					
Comment Code						
Inspector Comment						
FS_ID:17798 DS_ID:20605 EP_NO: N/A Repair Type: Non-Urgent Crossing Status: Indicator Found UCIP Comments: No permit identified for this crossing. FIELD_STRUCT_DESC: Fiber optics cable crossing of an unknown material. USA marker flags over crown along alignment of gate. FS Date: 8/20/2013

USAA markers along alignment at gate.

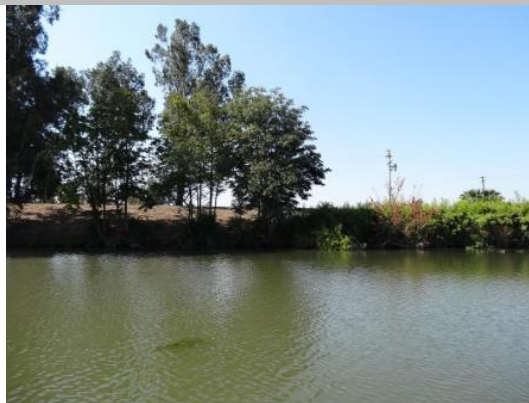
Photo 1 of 3 : SP_2019_RD0524_107_62_20190313_00088.jpg

Comment Code					
Inspector Comment					
09/13/2017: No significant change observed. 07/25/2016: No significant change observed. 06/24/2015: No significant change observed. 06/19/2014: No significant change observed. 08/13/2013: No significant change observed. 08/07/2012: The site has been visited by boat survey. No significant change observed 08/23/2011: No significant change observed on site. Trees concerned still in place. 09/07/2010: No significant change observed on site. The concern here is the undermining of the levee toe where most of trees are. There are erosion pockets lined along the lower slope and at the base of the trees, exposing tree roots. There is minimal slope protection. 09/29/2009: The lower slope is lined with minor erosion pockets; some tree roots are exposed; there is visible undermining of the levee toe; site is immediately upstream of the Highway 4 Bridge; the bridge is possibly causing a scour to occur, eroding the bank. [2017 Site ID:RD0524U01RM42.2]

Front view of the site where undermining has occurred.

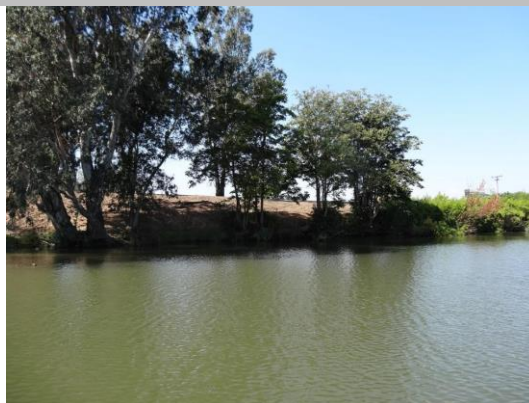
Photo 2 of 3 : SP_2019_RD0524_107_62_20190313_00089.jpg

Close view of the erosion.

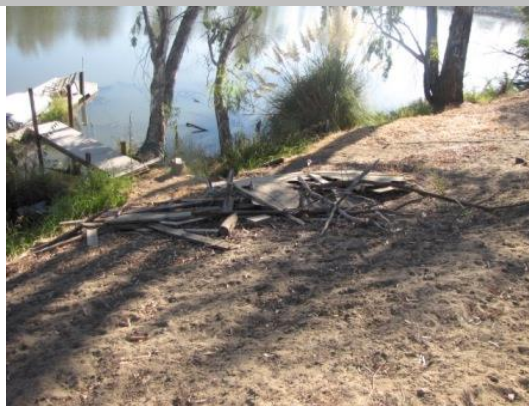
Photo 1 of 2 : SP_2019_RD0524_107_39_20190313_00054.jpg

LM Start	1.64	Rating **	U	Issue No.	39
LM End	1.64	Issue Type +	En	Location *	WS
Category	Earthen Levee			GPS Latitude/Longitude	
				Start	End
Item	Encroachments			37.927372 °	37.927372 °
				-121.327278 °	-121.327278 °
DWR ID	DWR_RD0524_01_s_2012_39				
Comment Code					
UR : Urban					
Inspector Comment					
Landowner constructed boat dock without permit.

Looking at garbage on waterside slope.
